WCFB Fuel Inlet Strainer

BY JIM FRAKES

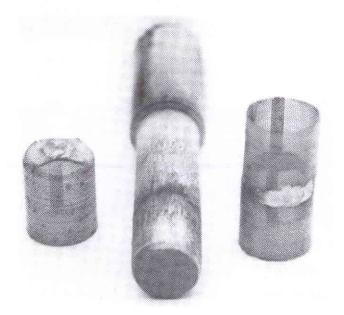
Standard #30-63 strainer on the left, duplicated WCFB strainer on the right.

The strainer is a tightly woven brass wire mesh tube, open at both ends. After many unsuccessful attempts locate a replacement strainer, I decided to duplicate it. The closest fuel strainer for a WCFB that I could locate was available from THE CARBURETOR SHOP, 1457 PHILADELPHIA #24, ONTARIO, CA 91761. 5 strainers and several miscellaneous springs cost me \$5.00. Strainer part #30-63 is apparently applicable to Carter models W-1, WA-1. This strainer is the correct diameter, however its length is too short and one end is folded closed. By using two strainers, cut apart and soldered together, an acceptable strainer can be made for the WCFB.

I turned down about a 2" length of ½ wood dowel to .400" diameter; this allowed the strainer to tightly slide over it. The open end of the strainer was taped to the dowel to prevent its rotating and then I carefully cut around the circumference of the strainer approximately ½" from the open end using a #11 X-ACTO blade. The dowel served as a mandrel. The second strainer was slid over the dowel, butted against the first and the two were lead soldered along the butted seam with a small soldering gun. Lastly, in order to make an open tube, the assembly was cut .890° from the open end. I washed off all traces of soldering flux with lacquer thinner.
