## '53 - '55 TOP FILLER FLAPS

By Roy Braatz

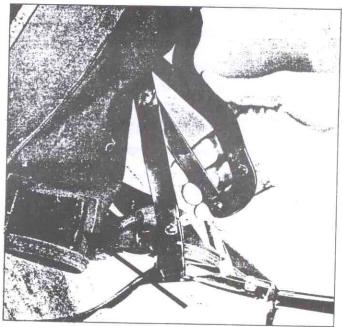
Most owners of '53 to '55 Corvettes have had problems with air getting into the cockpit area while driving with the soft top up and side windows installed. Other than a poor fit, which is understandable, many owners have gotten the top and windows to fit tight and proper but still complain of air hitting them in the neck when the window vent is opened.

Reproduction tops have now nearly duplicated the original down to the date codes, but have overlooked one little fact that a GM driver discovered early on when test driving the Corvette. "Filler flaps" that were used on all '53-'55 tops located between the lower bottom rear mohair seal and the bottom side snap hold down.

This is a poor picture taken from a GM service manual but shows the filler flap stitched to the top material. Having your local upholstery shop add them will cure the problem of cold air running up your neck and making the top more original.
