TECHNICAL SERVICE BULLETIN

Corvette Ventilator Window Lock - Tail

Pipe Extension

BULLETIN NO.: TSB #325

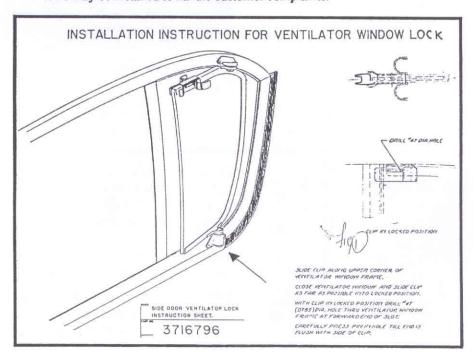
SIDE DOOR VENTILATOR LOCK

A Side Door Ventilator Lock to hold the Ventilator in the closed position has been released for production and service.

Slide Clip along upper corner of ventilator window frame.

Close ventilator window and slide clip as far as possible into locked position.

With clip in locked position drill #47 (.0785) diameter hole through ventilator window frame at forward end of slot.

Carefully press pin in hole till end is flush with side of clip.
